EUROPEAN COMMISSION
DIRECTORATE-GENERAL FOR ENERGY
SAVE II Programme

Energy Savings by CHCP plants in the Hotel Sector

Energy Audits - Portugal

May 2001

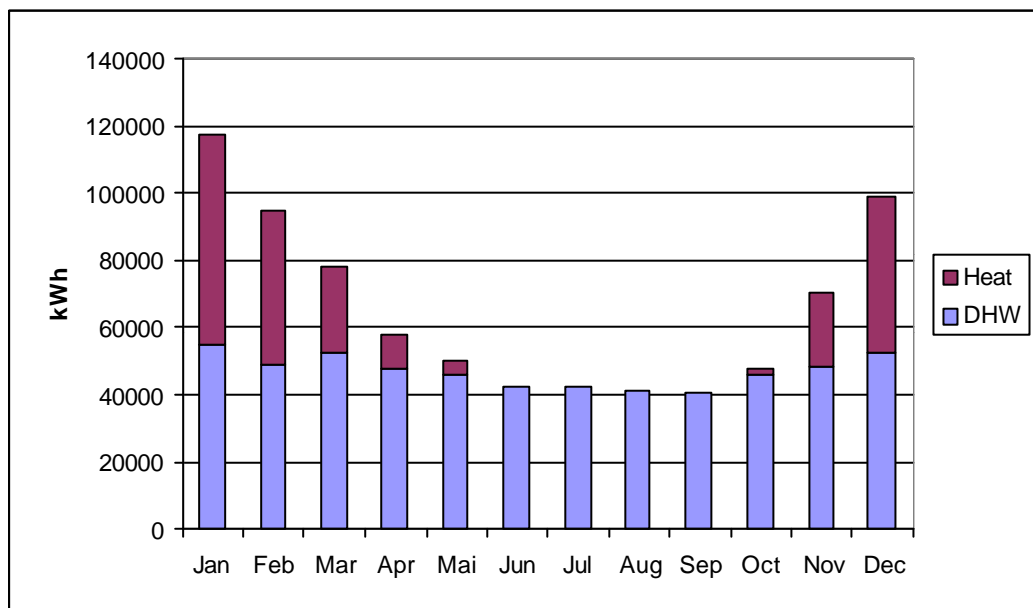
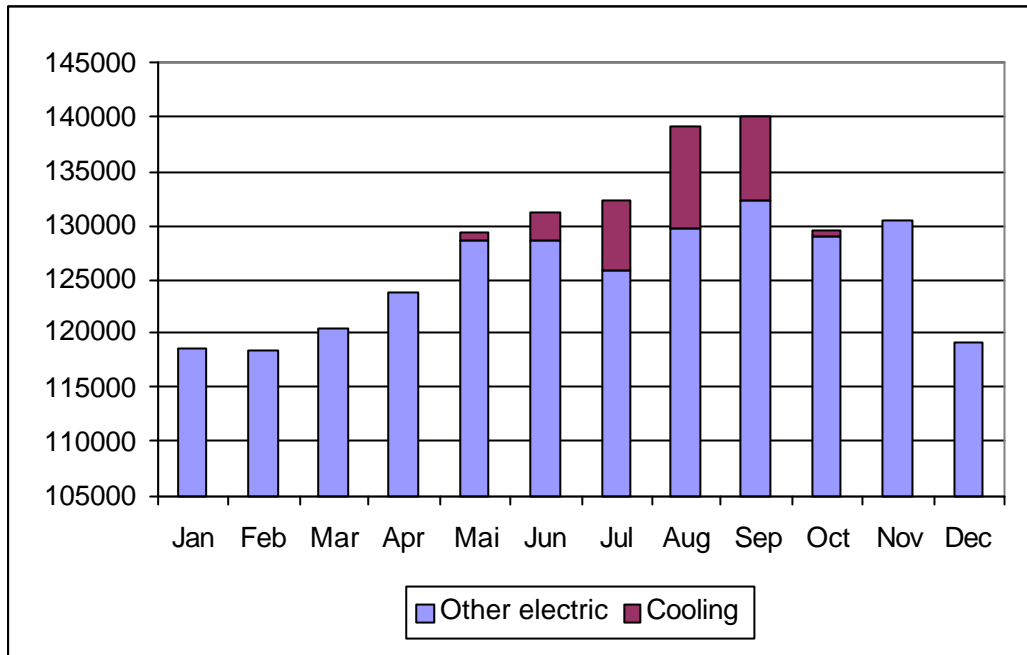
The heat for space heating and SHW is produced on a centralised manner in two heat pumps. The kitchen has it's own heat pump. At the time of the audit there was a resistance bank serially connected for adjusting the water temperature to the setting point. There are, however, plans for the installation of a natural gas boiler. The SHW is stored in two tanks with total capacity of 5000 litre.

The climate cooling is produced in the same reversible heat pumps. The conference rooms and suites have their own air-conditioned units.

Due to the use of electricity for acclimatisation and SHW purposes, this is of course the bigger electricity end-use. Lighting is as usual important.
